NATIONAL TRANSPORTATION SAFETY BOARD

RAILROAD ACCIDENT REPORT

SIDE COLLISION OF
TWO MISSOURI PACIFIC RAILROAD COMPANY
FREIGHT TRAINS
AT GLAISE JUNCTION,
NEAR POSSUM GRAPE, ARKANSAS
OCTOBER 3, 1982

NTSB/RAR-83/06

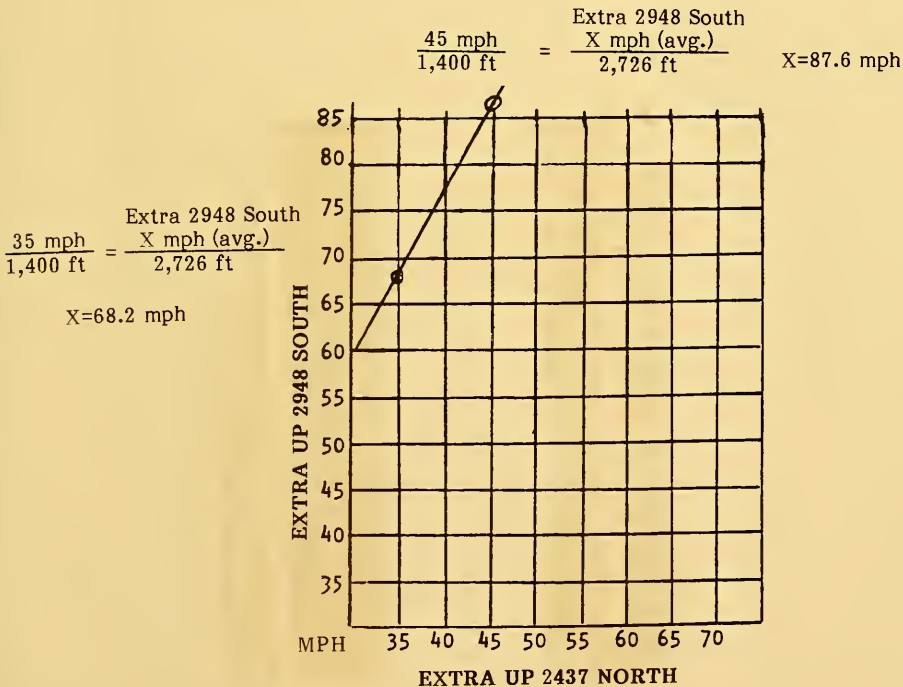
CALCULATED APPROXIMATE AVERAGE SPEED OF EXTRA UP 2948 SOUTH RELATIVE TO ANY SELECTED SPEED FOR EXTRA UP 2437 NORTH

The engineer of Extra UP 2437 North stated that the locomotives of the opposing trains met at the first road crossing north of Glaise Junction. The distance from the 10-foot clearance point (point-of-impact) for the switch at Glaise Junction to the road crossing was 2,726 feet. The overall length of Extra UP 2437 North was 4,781 feet. At the time the locomotives met at the road crossing, there would have been approximately 2,000 feet of Extra UP 2437 North south of the 10-foot clearance point at Glaise Junction. Because the point of impact at the eighth car ahead of the caboose of Extra UP 2437 North was about 600 feet from the rear of the train, approximately 1,400 feet of Extra UP 2437 North had to move past the 10-foot clearance point after the locomotives met at the crossing. The engineer of Extra UP 2437 North stated that his train was moving at slightly less than 50 mph. In order to allow for latitude in both the speed of Extra UP 2437 North and the proximity of their meeting point at the road crossing, the following graph indicates the relative average speed of Extra UP 2948 South between the road crossing and the point of impact:
